Lightning Air Terminal Collection Volume Assessment: A New Technique and Device

Abstract

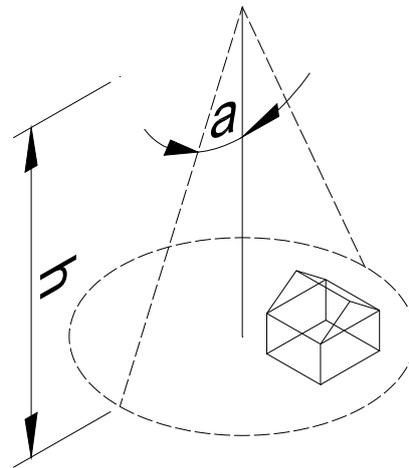
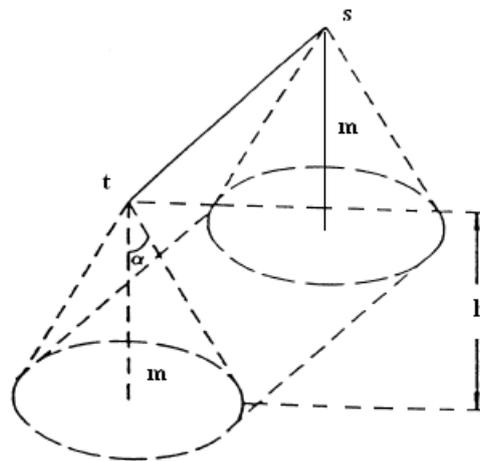
Figure 1. Protection Angle: (a) facility protected by a vertical lightning rod air terminal, a , is the protective angle; (b) protected by a wire air termination or horizontal metallic conductor indicated by ts for a pair of standing mast m of its equivalent of height h

On most turnkey projects involving petroleum facilities, and electrical transmission and distribution network main intake LPS are based on Cone of Protection / Protection Angle Method, IEC 62305 [7]. Cone of Protection is the creation of virtual 3-D cone with its apex point is at the top most point of the standing mast or monopole or vertical rod whether is standing independently or supported by a building structure. The virtual lightning collection volume is shown in Figure 1 and

The regeneration of volume of protection by laser beam based on Figure 1 can be a mean to check the building orientation and misalignment due to seismic activities and flood impact.

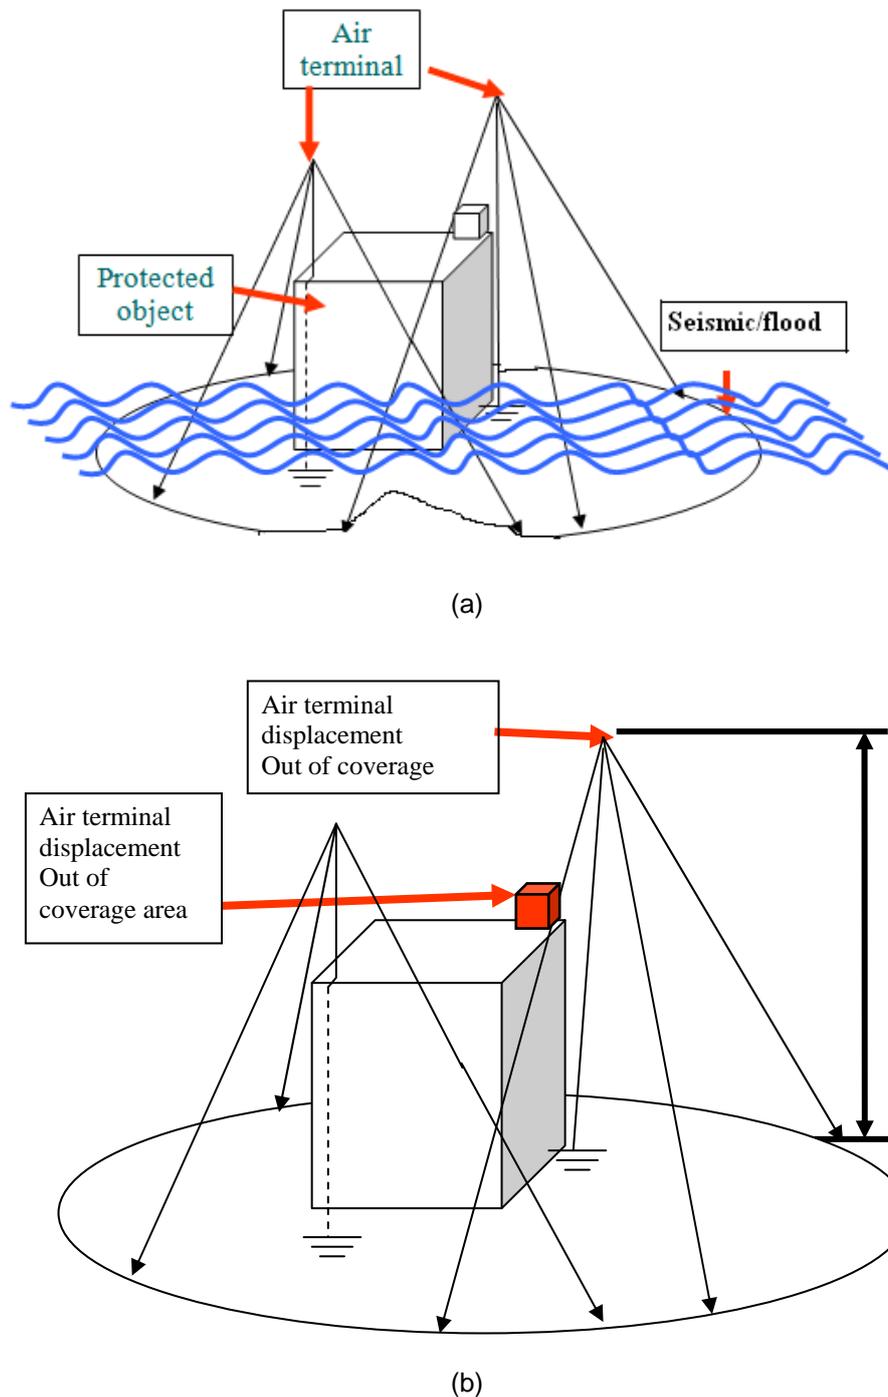
Figure 2. The cone volume of protection generated from a pair of air terminal. (a) Prior to seismic/flood impact; (b) The misalignment of the collection volume result in certain segment of facility expose to lightning direct strike

Figure 2 shows the collection volumes generated from a pair of air terminal. In

Figure 2(b) the environmental displacement due to the seismic activities and flood results misalignment of the lightning collection volume. This in time bring about some part of the facility expose to lightning direct strike. In another word the probability of lightning to strike that part of concern is higher compared to other parts. If this scenario involves petroleum or other inflammable and explosive items, the consequents of a direct strike is very fatal [17]-[20].

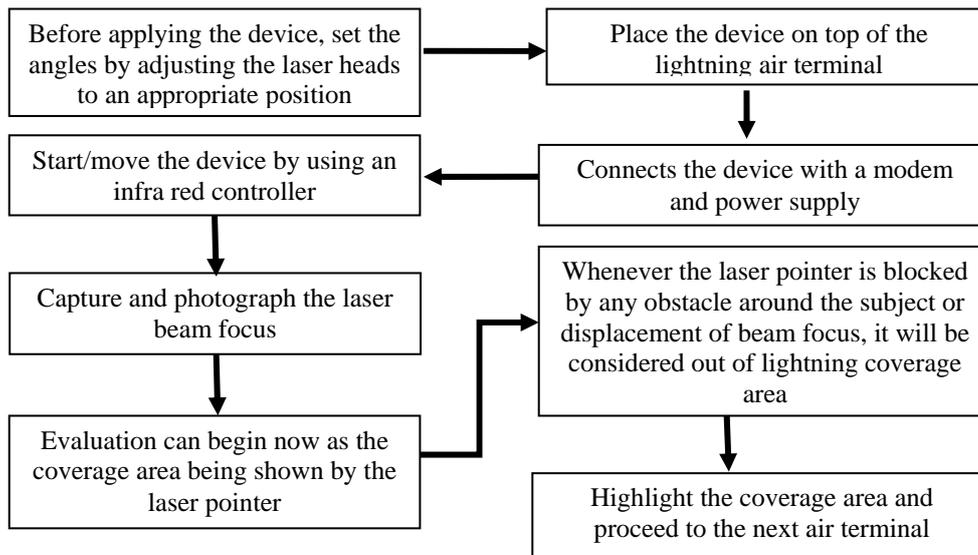
Figure 4. System functionality flowchart

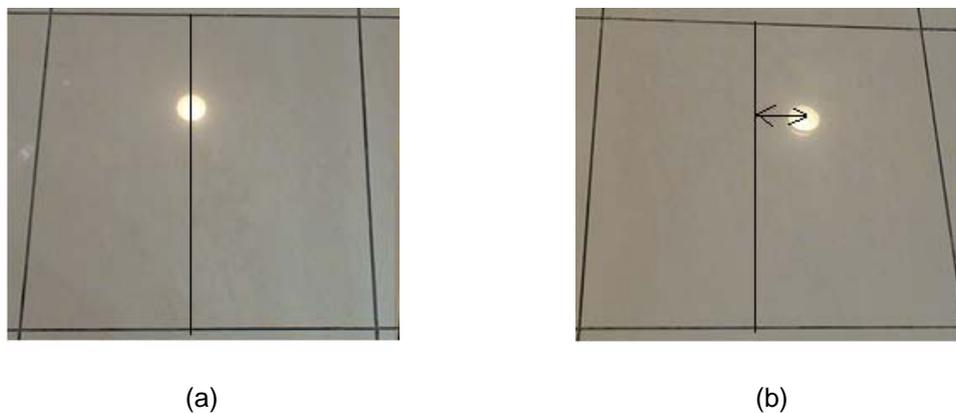
Figure 5. The image was recorded by using a camera which was affixed at the same position. (a) The previous image of laser beam focus and (b) The later image of the laser recorded where there was misalignment has taken place

The sensitivity and resolution of the laser beam images captured is very critical to determine the severity of seismic impact and flood displacement forces to the facilities. The camera should be an infra-red type that can record the low luminosity laser beam and they should continuously record the images while the instrument is used. The recorded images will be preserved for future reference.

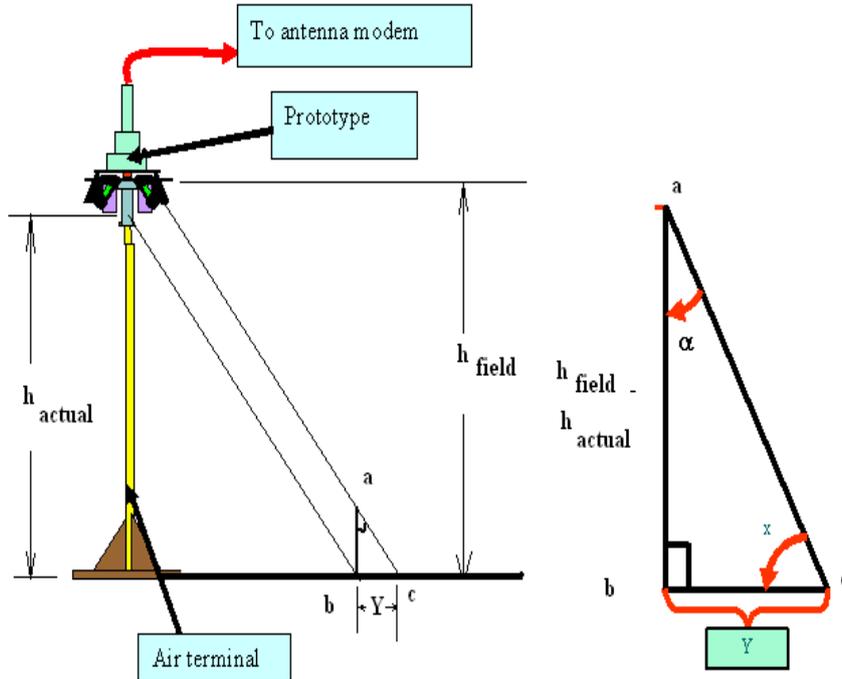
Figure 6. Slight error being introduced to the measurement

A systematic error is derived from the elevated positioning of the device which is placed on top of the lightning air terminal as shown in **Error! Reference source not found.**. This fact is seemingly unavoidable except when the laser pointer placement is the same point of the apex of the air terminal and the device is designed as such which is very thin and slim. But at this point of time, the length of the device is quite sizable however if the actual air terminal is of substantial height, the integrated error compounded due to this on the image captured by the camera is relatively neglected. Another source of error could be also emerged if the lightning air

terminal is tilted. In **Error! Reference source not found.**, the fractional comparison between Y and h_{actual} and also $x' - x$ with h'_{field} is very small. Thus the slight image displacement captured by the camera can be neglected and assume quite correct.

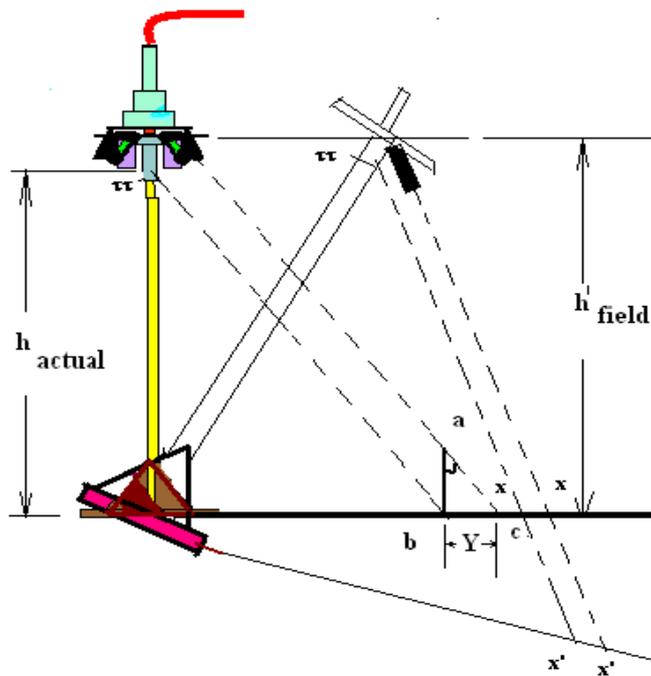
Figure 7. The error involve in the tilting of building which correspondingly tilt the lightning air terminal
