## Electrical Tracking Formation on Silane Epoxy Resin under Various Contaminants

Contamination at the surface of the insulator becomes a serious problem. Especially for the tropical area, humidity and rainfall play an important role in wetness by the water at the insulator surface, which result in the presence of contaminant and leakage current flowing at the surface. This leakage current will generate heat which occurs at the surface of an insulator. This ultimately leads to flashover. This paper presents the influence of contaminants to leakage current and formation of electrical tracking at the surface of epoxy resin compound with silicon rubber. The test was based on IPT method with  $\text{NH}_4\text{Cl}$  as contaminants. The industrial and coastal contaminants are used to explain the effect of contaminant at surface tracking process. The flow rate of contaminant was 0.3 ml/min. The 3.5 kV AC high voltage 50 Hz was applied to the top electrodes. It is found that industrial contamination resulting in the smallest surface leakage current is 327.6 mA. Also it is found that coastal contaminant showed the severest damage at surface of test sample. Therefore, special treatment of

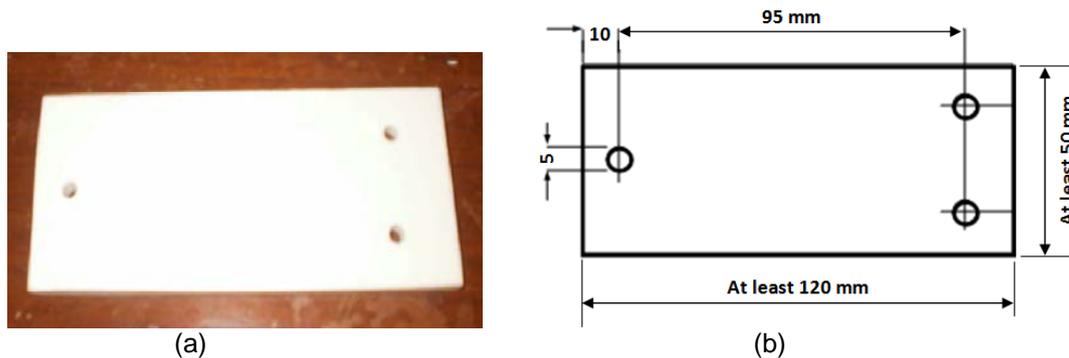
The samples were prepared in the form of blocks with dimension of 50 mm x 120 mm x 6 mm. Test samples were drilled to place electrodes as illustrated in Figure 1 (a) and (b) :

Figure 1. (a) Physical view of test sample and (b) Schema of test sample and its dimension

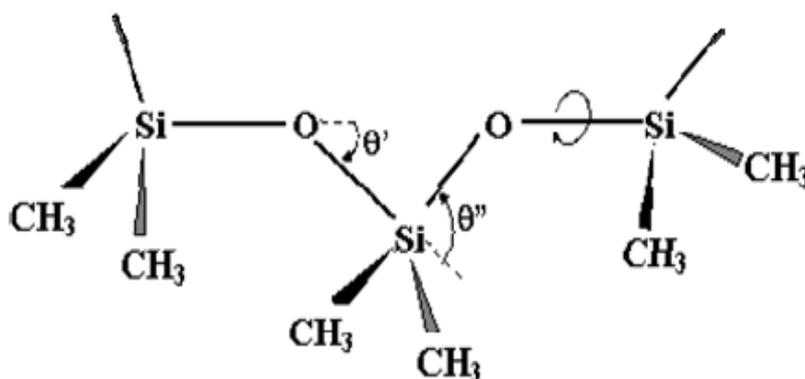
Silicon rubber is a PDMS which has  $\text{CH}_3$  as side group. Different chemical compound in every bond will give different property for each polymeric material [15]. Silicon rubber chemical structure has more flexible siloxane backbone compared to other polymeric material. This flexibility advantage can be understood by chain structure shown in Figure 3.

Figure 3. Silicon rubber chain structure

Silicon rubber chain structure doesn't have carbon at the backbone, but present at side group. Those structure show semi-organic structure with high bond energy of S-O which gives very high thermal stability. Bond energy of Si-O is 25% higher than C-C in ethylene backbone. The comparison of main bond energy of several polymeric compound is shown in Table 1.

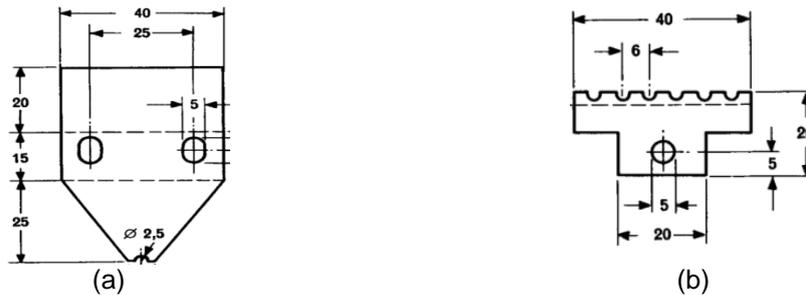
All electrodes, fixtures and assembly elements associated with the electrodes, such as screws, shall be made of stainless steel material [17]. The electrode assembly is shown in Figure 4 (all dimension in mm). The top electrode is shown in Figure 4.a and the bottom electrode is shown in Figure 4.b.

Figure 4. (a) Top, (b) Bottom of the electrodes

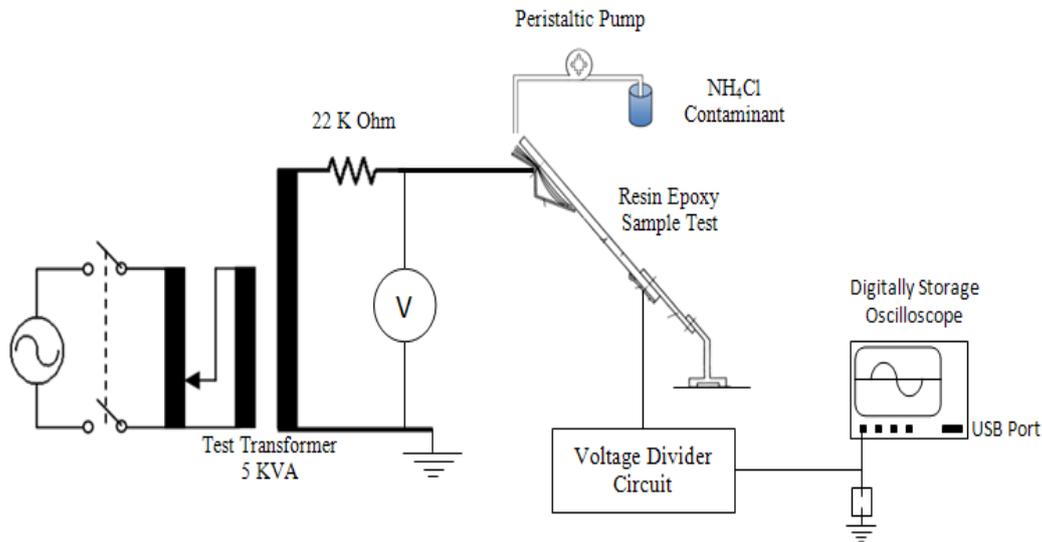
The tests were carried out using a high voltage AC 50 Hz. The test voltage 3.5 kV was applied to the top electrode while a contaminant flowed along the underside of the sample. In this test, method 1 : the constant tracking voltage was used, and the time to start tracking was also determined. The schematic diagram for this test is illustrated in Figure 6.

Figure 6. Schematic diagrams for this test.

High voltage AC 50 Hz with a voltage of 3.5 kV was generated from 5 kVA transformer test. Resistor 22 k $\Omega$  was used to resist the current flowing on the surface of the material in the event of discharge. Peristaltic pump was used to drain the solution of contaminants.

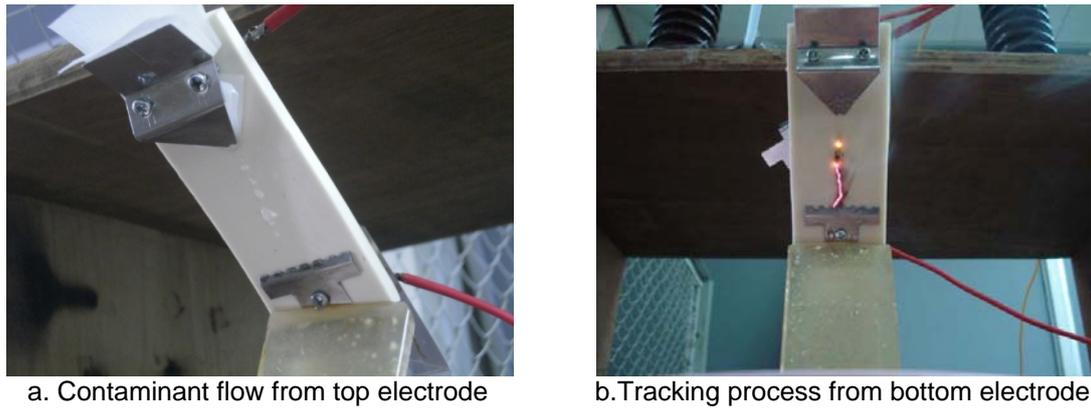
Discharge current will be read and recorded by Oscilloscope in time of discharge at the surface of the material. Measurement data in the form of discharge current and discharge time of the first occurrence was then stored and used to analyze the surface condition. Figure 7 below describe the flow of contaminant from top electrode (Fig.7.a) while the formation electrical track from the bottom electrode (Fig.7.b).

Figure 7. The electrical tracking processes at the surface of insulation

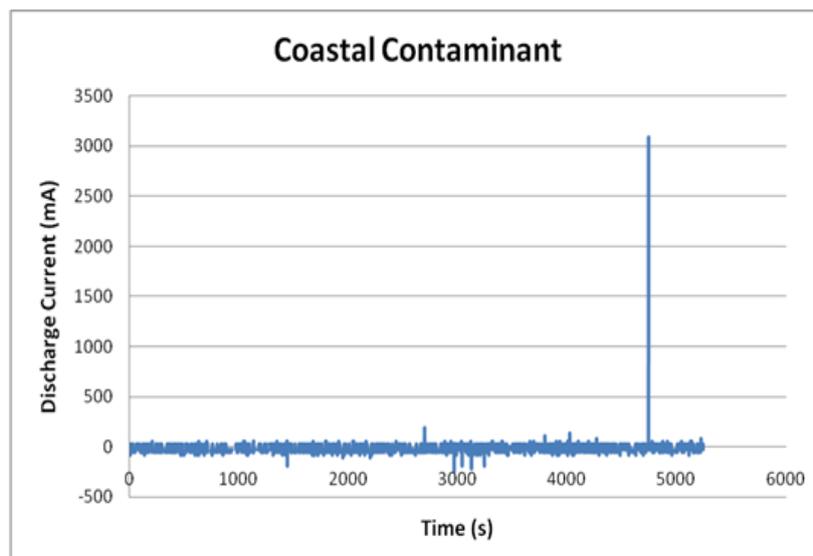
Figure 8. Leakage current with coastal contaminant

Based on Figure 8 we know the discharge started to occur at 4746 second for coastal contaminant ( 1420  $\mu\text{S}/\text{cm}$ ) and at 550 second for  $\text{NH}_4\text{Cl}$  (2170  $\mu\text{S}/\text{cm}$ ) in Figure 9 and at 818 second for industrial contaminant (3540  $\mu\text{S}/\text{cm}$ ) in Figure 10.

Figures 8, 9 and 10 show the influence of contaminant on leakage current of test samples. Also, we know that the first discharge time and current discharge are influenced by the conductivity of the contaminant. The conductivity of contaminant plays an important role in increasing the surface tracking at the surface of polymer materials. At a very high conductivity ( $3540 \mu\text{S}/\text{cm}$  as industrial contaminant), the current discharge is smallest. Meanwhile for coastal contaminant with  $1420 \mu\text{S}$ , it needs longer time to discharge occurred but the current discharge was very high. Contaminant at the surface of the material with high conductivity tends to become conductive bridge between top and bottom electrode when the contaminant was flowed.

Comparing figures 8, 9 and 10, it is concluded that conductivity of contaminant plays an important role in initiate the leakage current.

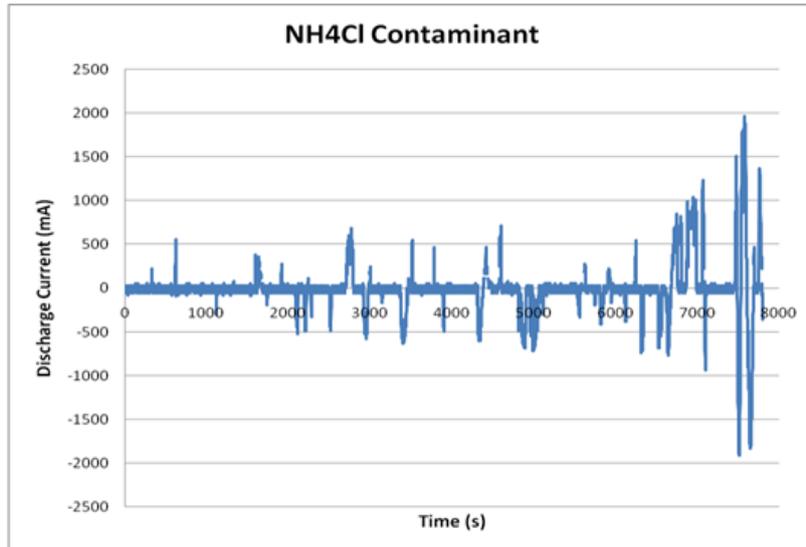
Figure 9. Leakage current with  $\text{NH}_4\text{Cl}$  contaminant

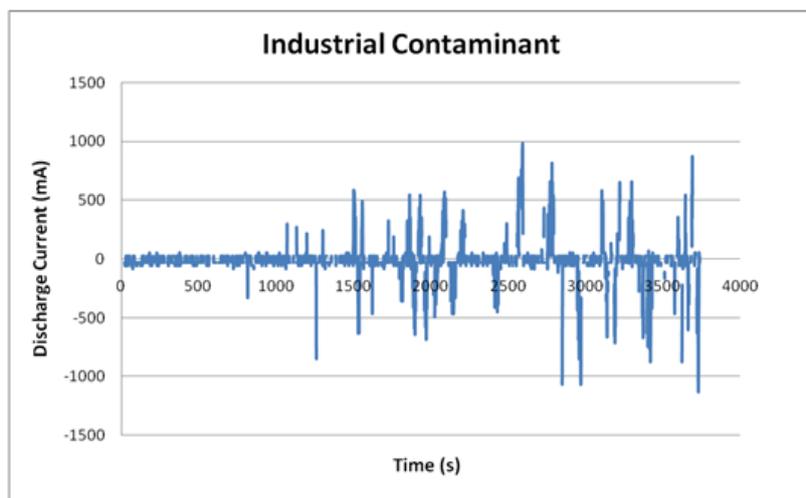
Figure 10. Leakage current with industrial contaminant

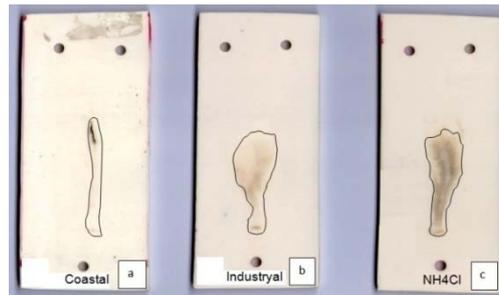
Figure 11. Surface conditions after test

Figure 11 (a) shows the track on epoxy resin sample with coastal contaminant. The track is a partially-conducting path created by localized deterioration on the surface of an insulating material. Formation of The track begins from top electrode. But, Figure 11(b) and (c) show the track start from bottom electrode. X. Wang [3] investigated the tracking induced on polystyrene sample using acid rain and  $\text{NH}_4\text{Cl}$ . The track on virgin sample is narrow and shallow, like a bean sprout, but that on aged samples spreads all over, like the jungle. It is clear that the discharge and tracking on an aged sample are severer than those on a virgin sample, and tracking is easily induced on the aged sample. When a virgin sample is subjected to the tracking test using acid rain contaminant instead of the  $\text{NH}_4\text{Cl}$  solution, the track propagates and penetrates deeply into the sample like Figure 12 and 14, the reason being that the artificial acid rain used is severer than the  $\text{NH}_4\text{Cl}$  solution, i.e. has higher acidity and conductivity.

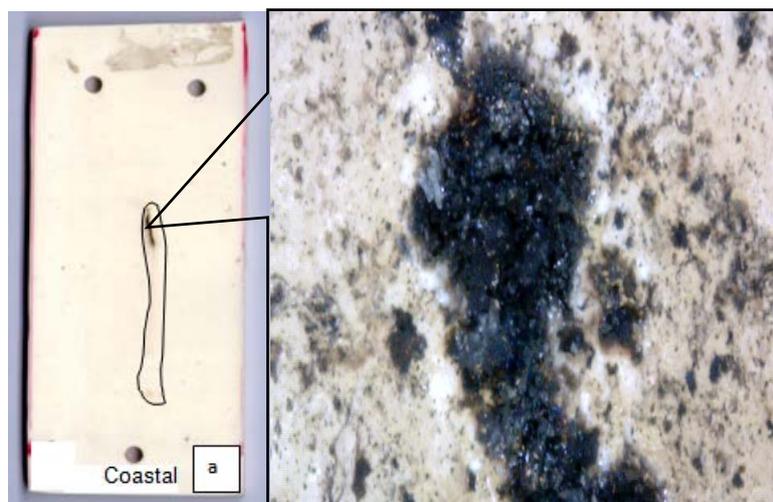
Figure 12. Surface condition with coastal contaminant

From the figures 12, 13 and 14, we know that severest damage of sample surface was with coastal contaminant (Fig.12). The forming of carbon happen at the sample surface. This also happen at the sample with  $\text{NH}_4\text{Cl}$  contaminant (Fig. 14), however, samples with industrial contaminants had wider surface damage than that of the coastal contaminant (like bush).

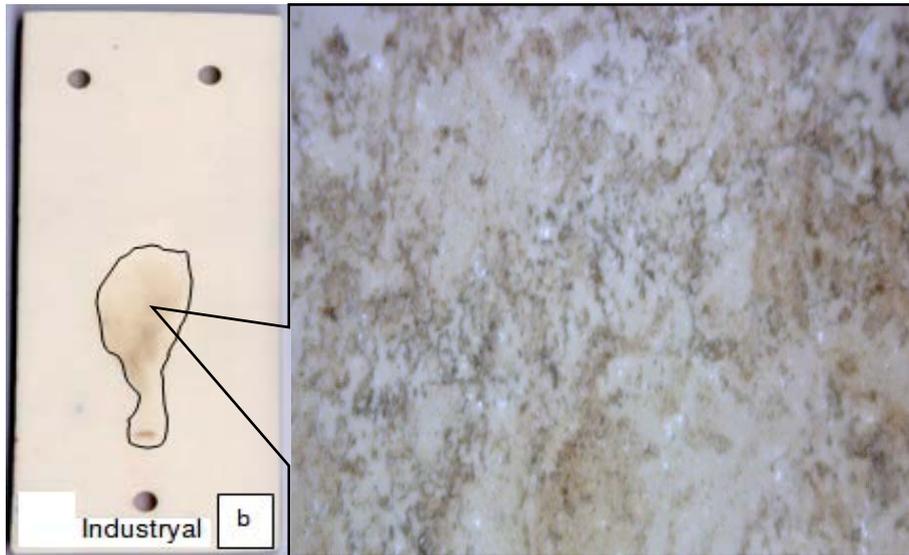
Figure 13. Surface condition with industrial contaminant

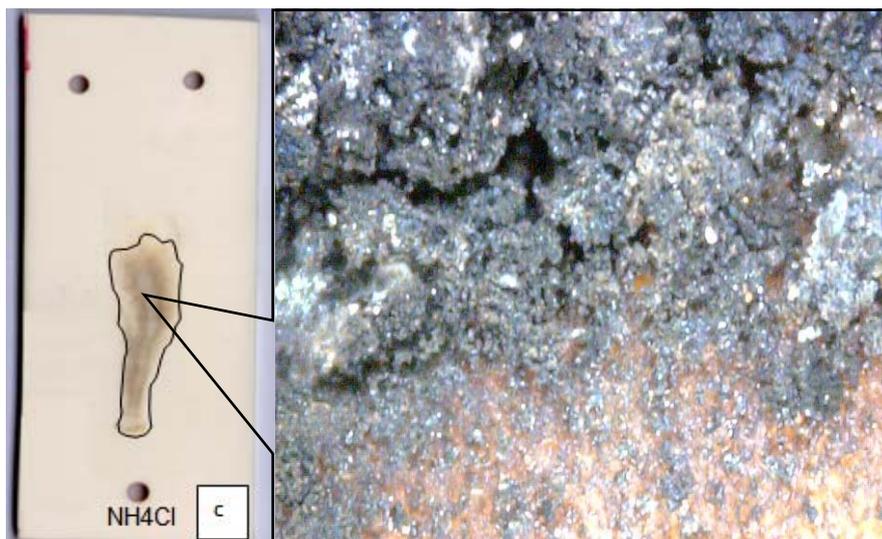
Figure 14. Surface condition with  $\text{NH}_4\text{Cl}$  contaminant
